City Park Mile High Loop 2015 Trail Condition and Assessment

The following assessment is provided to Denver Parks and Recreation by the City Park Alliance to assist with recommendations for maintenance and rehabilitation of the Mile High Loop trail in City Park. All decisions on maintenance, and capital construction in City Park are to be directed through the City of Denver's Parks and Recreation department.

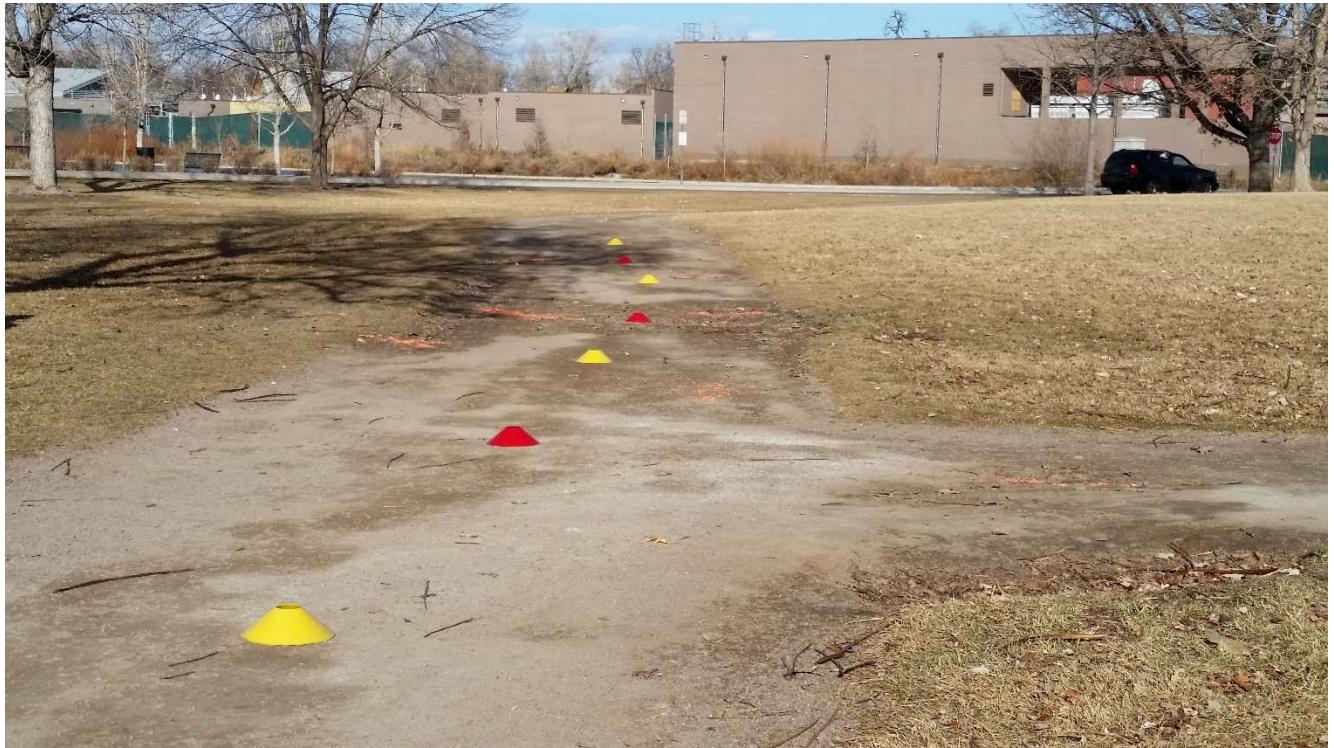
Problem Area 1

This area is highly saturated throughout summer months due to irrigation flows being consolidated in a low lying area with no cross slope.

- 160 cubic feet of fill (60x.33x8)

- o 0.33 = 4" to be added to trail for drainage in problem areas
- o (x8) Trail is variable in width and a mean width of 8 feet is used calculations
- o 20% compaction is not factored as roughly only 80% of the trail will be raised in an effort to provide adequate sloping and to avoid a dropoff on the trail edge

- Crowning of the trail from the center with no outsloping
- Trail elevation of 4" above surrounding grade

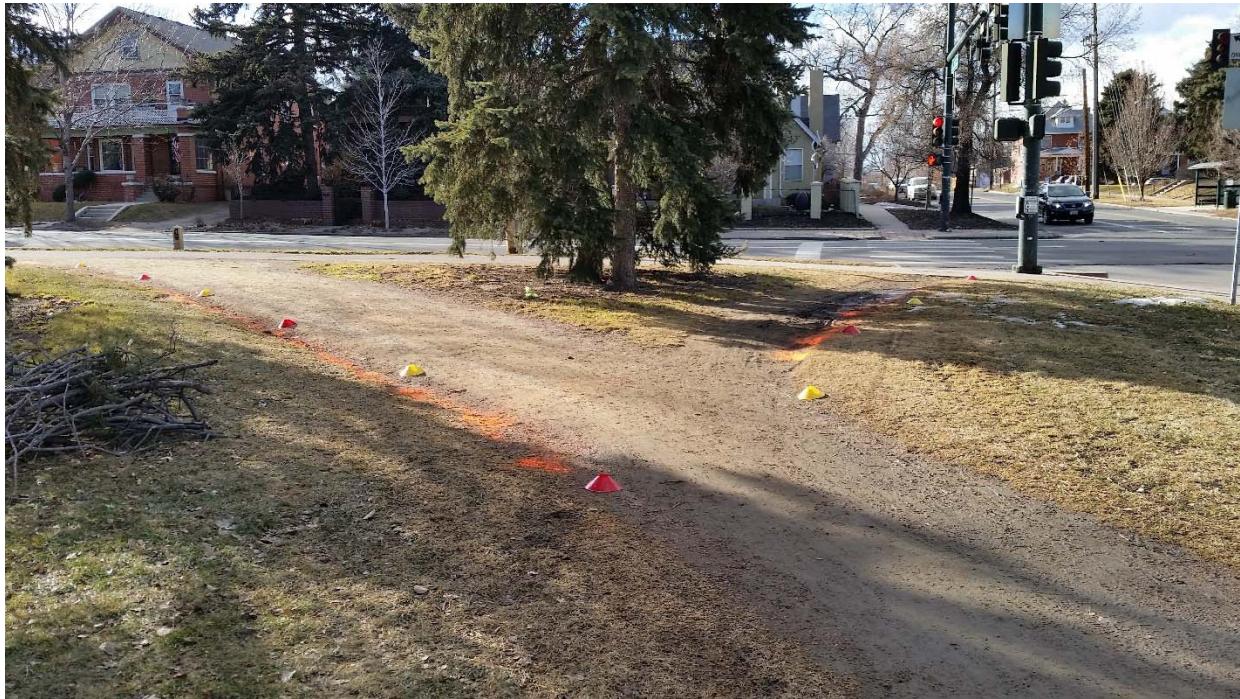
Problem Area 2

This area is highly saturated throughout summer months due to irrigation flows being consolidated along the interior edge of the trail. A second unofficial trail has been formed where the crosswalk at 23rd Avenue and York Street ends. This area is particularly eroded as it has not been designed to be a trail.

- 156 cubic feet of fill ($50 \times .33 \times 8$) (132) + ($30 \times .5 \times 5 \times 1.2$) (24)
- cubic feet fill needed is defined as the length of trail to repair in feet X 0.33

- o 20% compaction was factored in for new trail fill (1.2)
- Elevation of the trail 4" above grade with an outslope following grade
- Backfill or formal excavation and trail preparation where the newly formed trail meets the Mile High Loop

- Consider a drainage ditch if rills continue to form

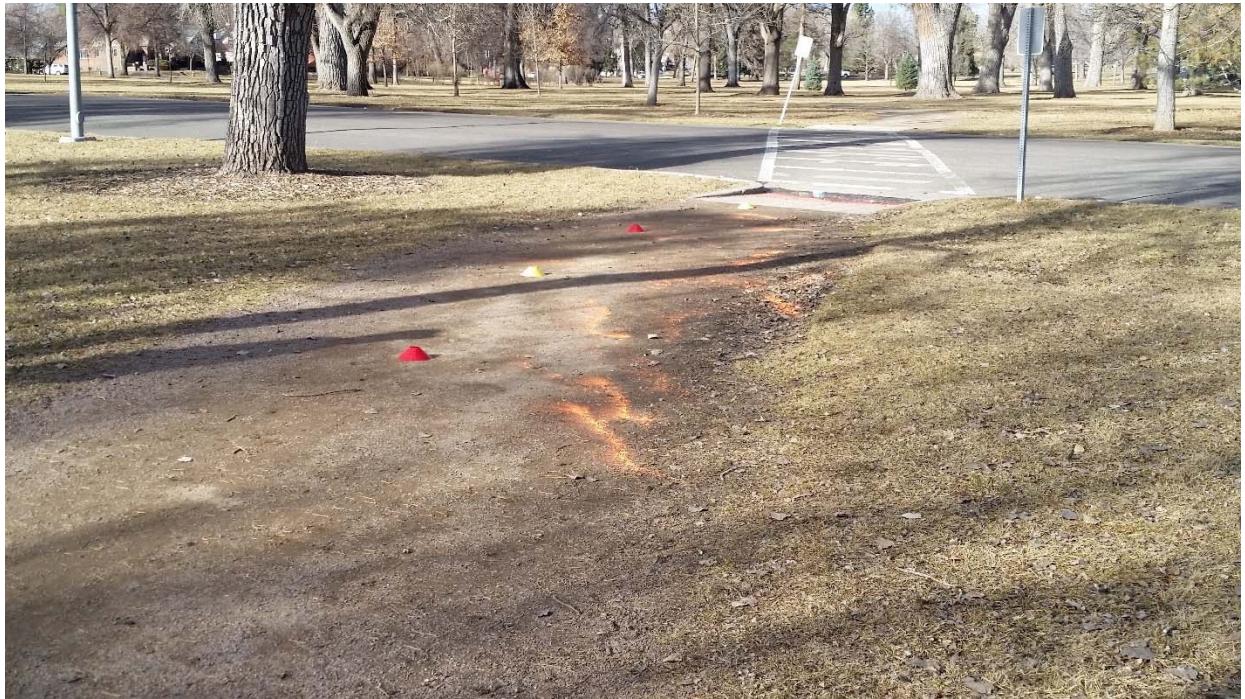
Problem Area 3

This area includes a slope varying from 2-5 degrees. In this picture, the direction of slope is from the foreground to the background. Water pools and creates a large section of mud during summer months at the toe of the slope.

- 80 cubic feet of fill (30x.33x8)
- cubic feet fill needed is defined as the length of trail to repair in feet X 0.33
 - o $0.33 = 4"$ to be added to trail for drainage in problem areas
 - o (x8) Trail is variable in width and a mean width of 8 feet is used calculations
 - o 20% compaction is not factored as roughly only 80% of the trail will be raised in an effort to provide adequate sloping and to avoid a dropoff on the trail edge
- Elevation of the trail 4" above grade with both crowning and a slope following grade to the street intersection
- Consider a drainage ditch on the downhill side if rilling/pooling continues

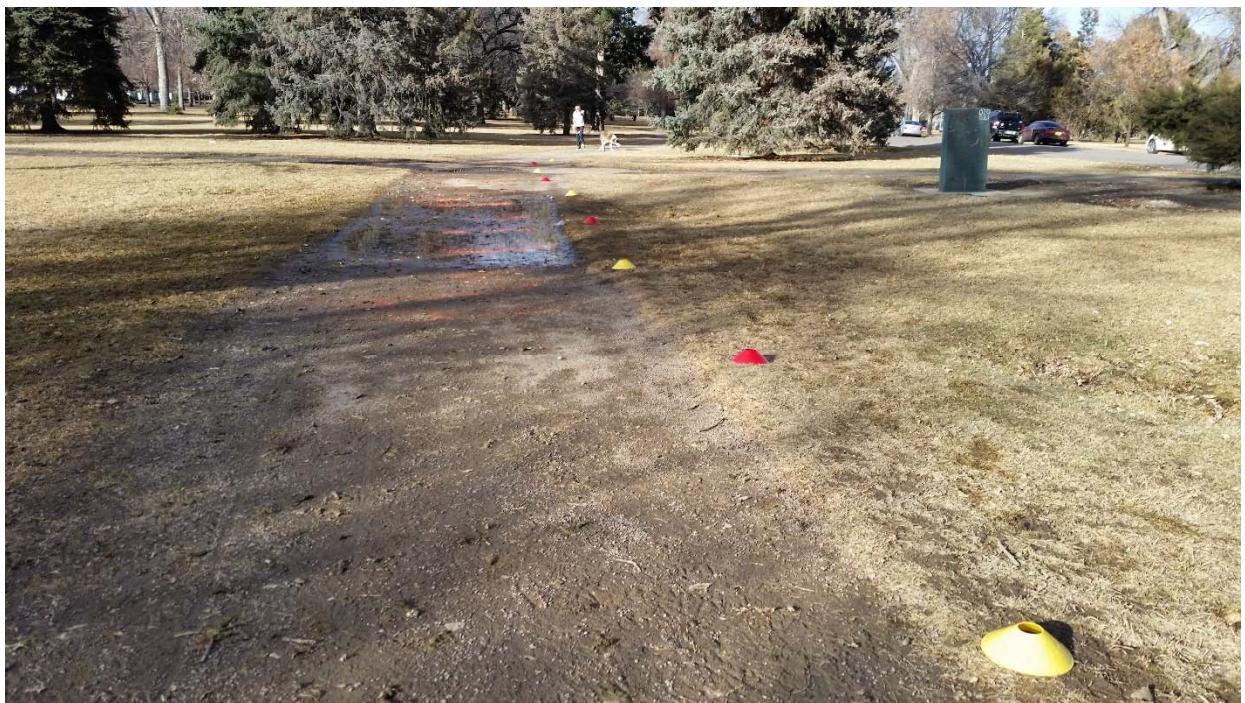
Problem Area 4

This area is highly saturated throughout summer months due to irrigation flows being consolidated in a low lying area with no cross slope.

- 160 cubic feet of fill (60x.33x8)
- cubic feet fill needed is defined as the length of trail to repair in feet X 0.33
 - o $0.33 = 4"$ to be added to trail for drainage in problem areas
 - o (x8) Trail is variable in width and a mean width of 8 feet is used calculations
 - o 20% compaction is not factored as roughly only 80% of the trail will be raised in an effort to provide adequate sloping and to avoid a dropoff on the trail edge
-
- Crowning of the trail from the center with no outsloping
- Trail elevation of 4" above surrounding grade

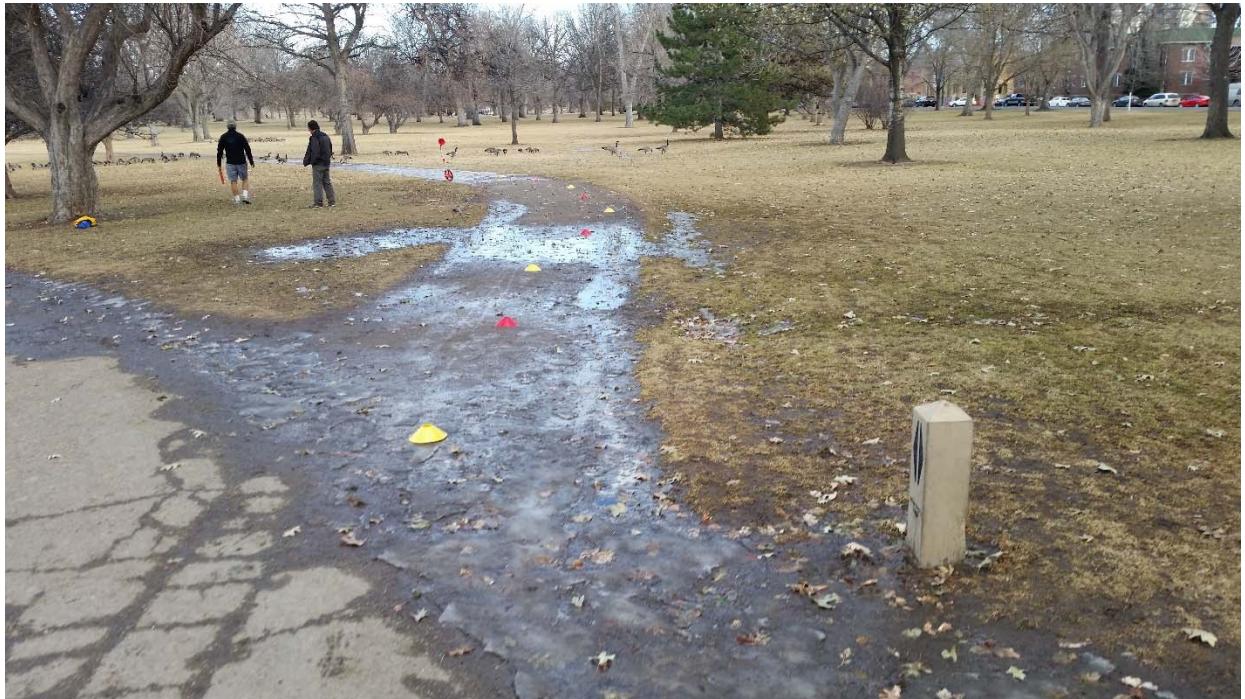
Problem Area 5

This area is highly saturated throughout summer months due to irrigation flows being consolidated throughout this portions of the trail. This area is affected in winter by slight shading from a large grove of trees which creates differential melting.

- 160 cubic feet of fill (60x.33x8)
- cubic feet fill needed is defined as the length of trail to repair in feet X 0.33
 - o $0.33 = 4"$ to be added to trail for drainage in problem areas
 - o (x8) Trail is variable in width and a mean width of 8 feet is used calculations
 - o 20% compaction is not factored as roughly only 80% of the trail will be raised in an effort to provide adequate sloping and to avoid a dropoff on the trail edge
- Elevation of the trail 4" above grade with an outslope following grade

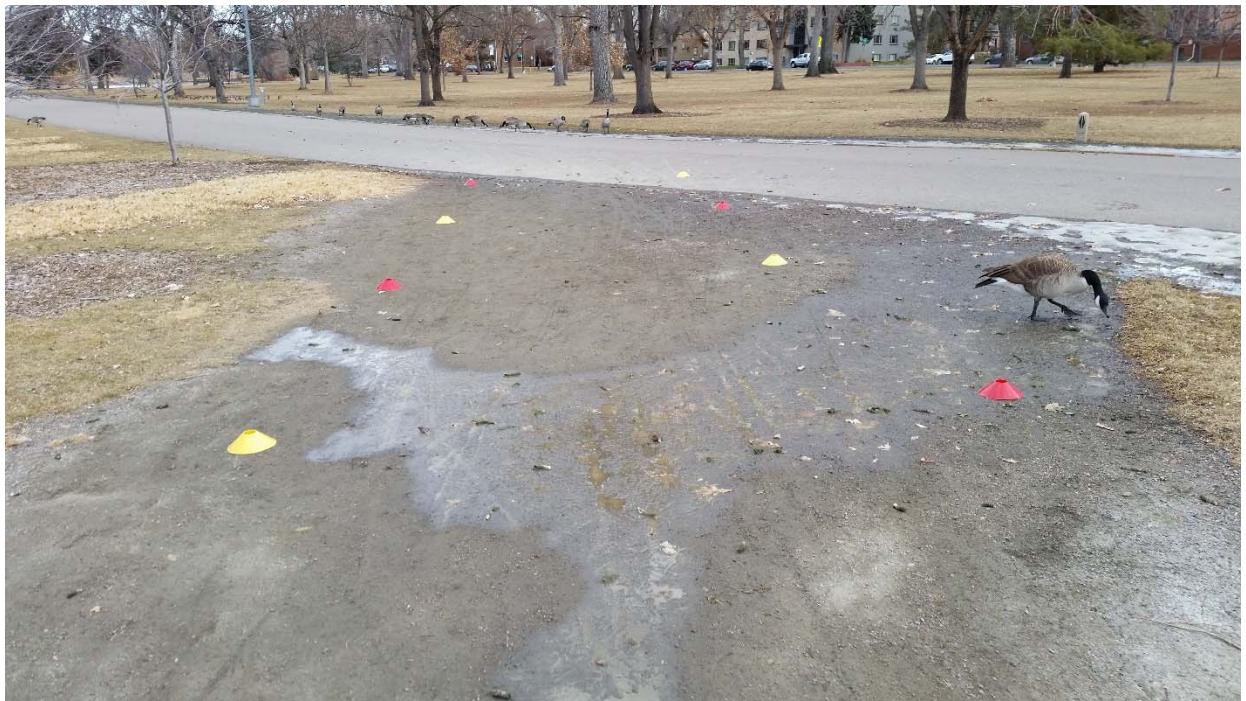
Problem Area 6

This area is highly saturated throughout summer months due to flows and sediment being delivered from the uphill immediately adjacent impervious surface. A slope exists which conveys water from the road onto the trail.

- 80 cubic feet of fill ($30 \times .33 \times 8$)
- cubic feet fill needed is defined as the length of trail to repair in feet X 0.33
 - o $0.33 = 4"$ to be added to trail for drainage in problem areas
 - o ($\times 8$) Trail is variable in width and a mean width of 8 feet is used calculations
 - o 20% compaction is not factored as roughly only 80% of the trail will be raised in an effort to provide adequate sloping and to avoid a dropoff on the trail edge
- Elevation of the trail 4" above grade with crowning to distribute run-on away from the trail
- Future consideration of using elevation, porous materials or level spreaders to drain roadway runoff prior to intersection with the trail
- Signage to restrict maintenance vehicles and event vehicles using the road from using the loop trail.

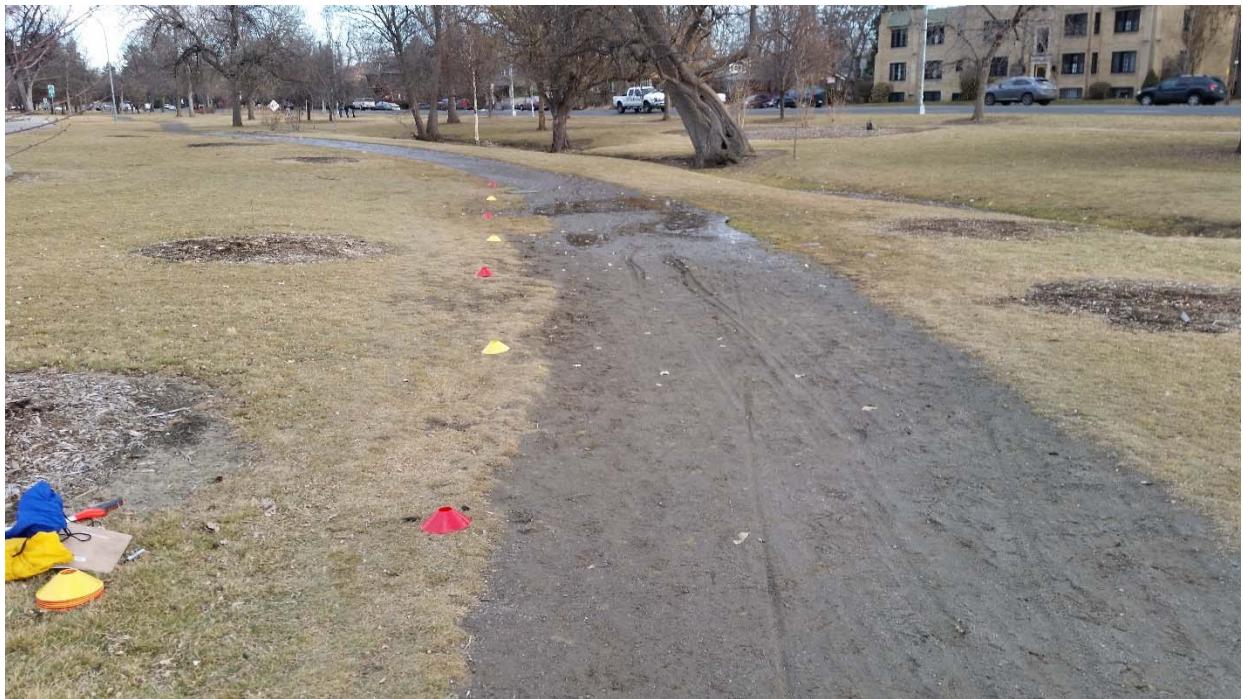
Problem Area 7

Areas 7 and 8 are low lying areas that are hit particularly hard with irrigation runoff. These areas are often impassable for the majority of the summer due to high run-on and minimal cross-slope.

- 158 cubic feet of fill (60x.33x8)
- cubic feet fill needed is defined as the length of trail to repair in feet X 0.33
 - o $0.33 = 4"$ to be added to trail for drainage in problem areas
 - o (x8) Trail is variable in width and a mean width of 8 feet is used calculations
 - o 20% compaction is not factored as roughly only 80% of the trail will be raised in an effort to provide adequate sloping and to avoid a dropoff on the trail edge
- Crowning of the trail from the center with no outsloping
- Trail elevation of 4" above surrounding grade
- Planting of trees to the north of the trail to replace former tree islands and to provide additional infiltration and interception of irrigation
- Consider subsurface drainage to "Little Lake" via the adjacent drainage swale if problems persist

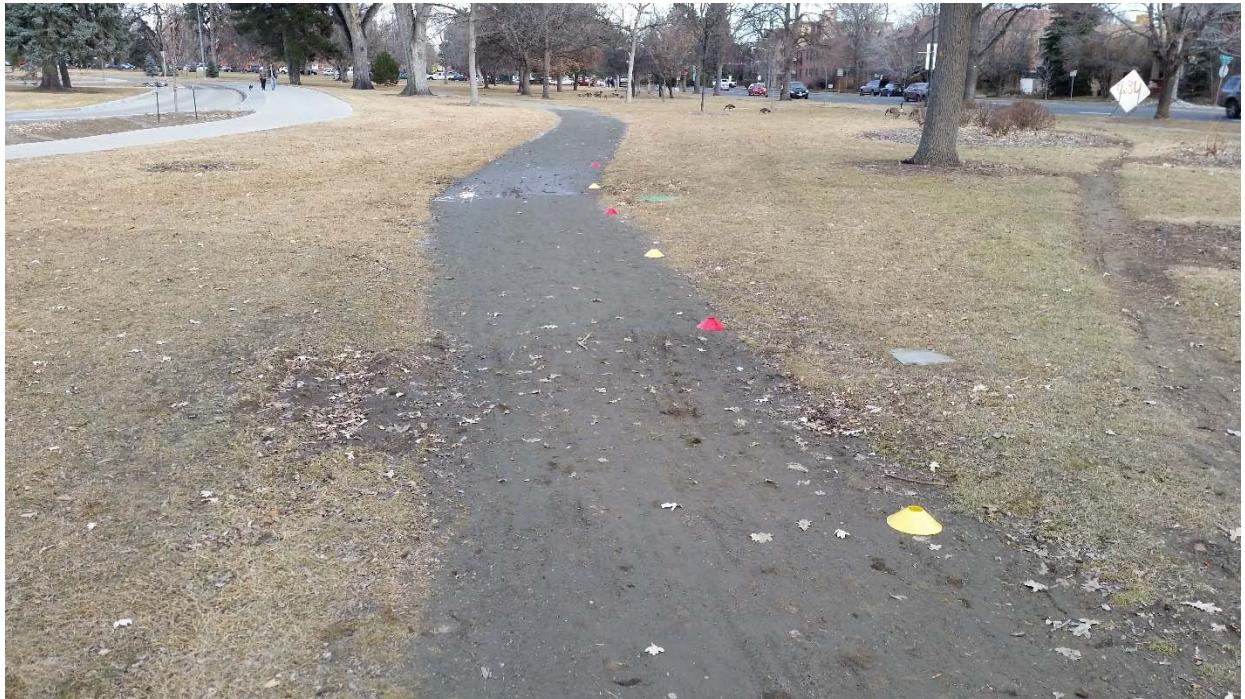
Problem Area 8

Areas 7 and 8 are low lying areas that are hit particularly hard with irrigation runoff. These areas are often impassable for the majority of the summer. A second trail which veers to the right of the Mile High Loop in this picture was created by foot traffic when this portion of the trail was closed during construction of a museum expansion and roadway improvements from 2012-2014.

- 158 cubic feet of fill (60x.33x8)
- cubic feet fill needed is defined as the length of trail to repair in feet X 0.33
 - o $0.33 = 4"$ to be added to trail for drainage in problem areas
 - o (x8) Trail is variable in width and a mean width of 8 feet is used calculations
 - o 20% compaction is not factored as roughly only 80% of the trail will be raised in an effort to provide adequate sloping and to avoid a dropoff on the trail edge
- Crowning of the trail from the center with no outsloping
- Trail elevation of 4" above surrounding grade
- Re-vegetation of the trail that was created during museum construction
- Consider ditching which connects to subsurface drainage to "Little Lake" if problems persist

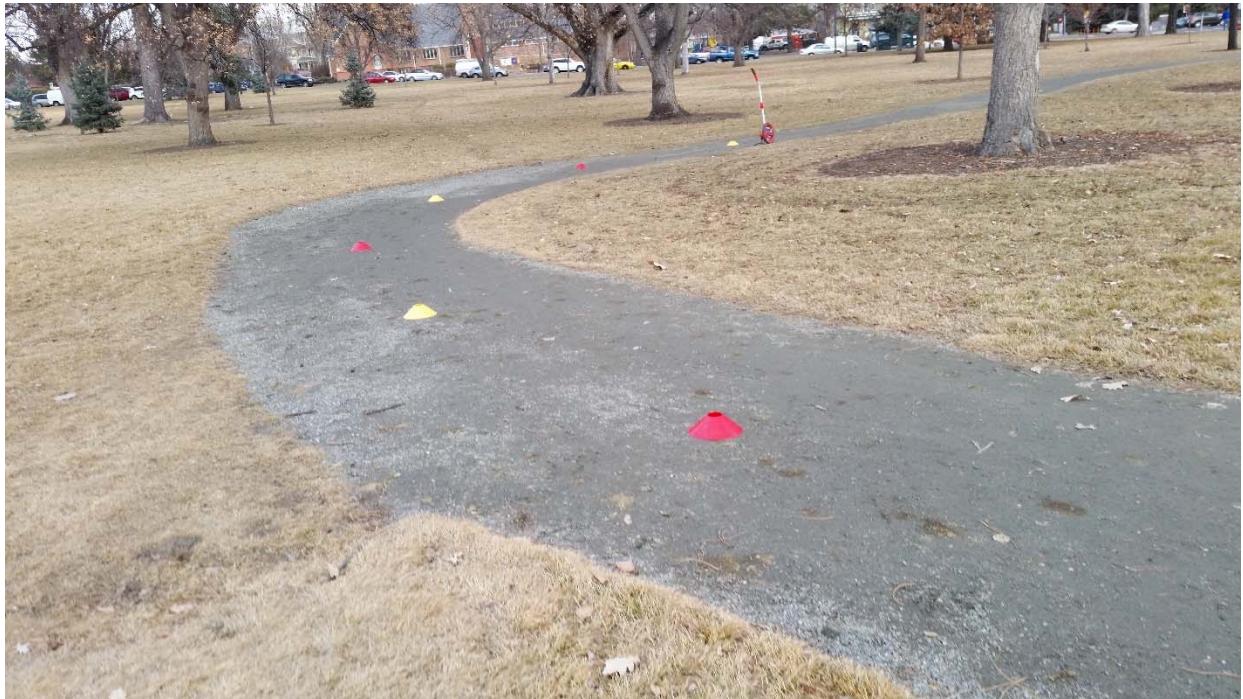
Problem Area 9

This area is a new segment of the trail that was created when it was necessary to re-orient the trail to accommodate reclaimed water infrastructure (aka “purple pipe). This area has impacts from bicycle traffic as it both connects the bike trail in the park to the intersection of Colorado Boulevard and 17th Avenue and incorporates an acute angled arc. Mechanical grooming of the trail in October, 2014 greatly improved the surface in this area.

- 136 cubic feet of fill (50x.33x8)
- cubic feet fill needed is defined as the length of trail to repair in feet X 0.33
 - o $0.33 = 4"$ to be added to trail for drainage in problem areas
 - o (x8) Trail is variable in width and a mean width of 8 feet is used calculations
 - o 20% compaction is not factored as roughly only 80% of the trail will be raised in an effort to provide adequate sloping and to avoid a dropoff on the trail edge
- Elevation of the trail 4" above grade with an outslope following grade

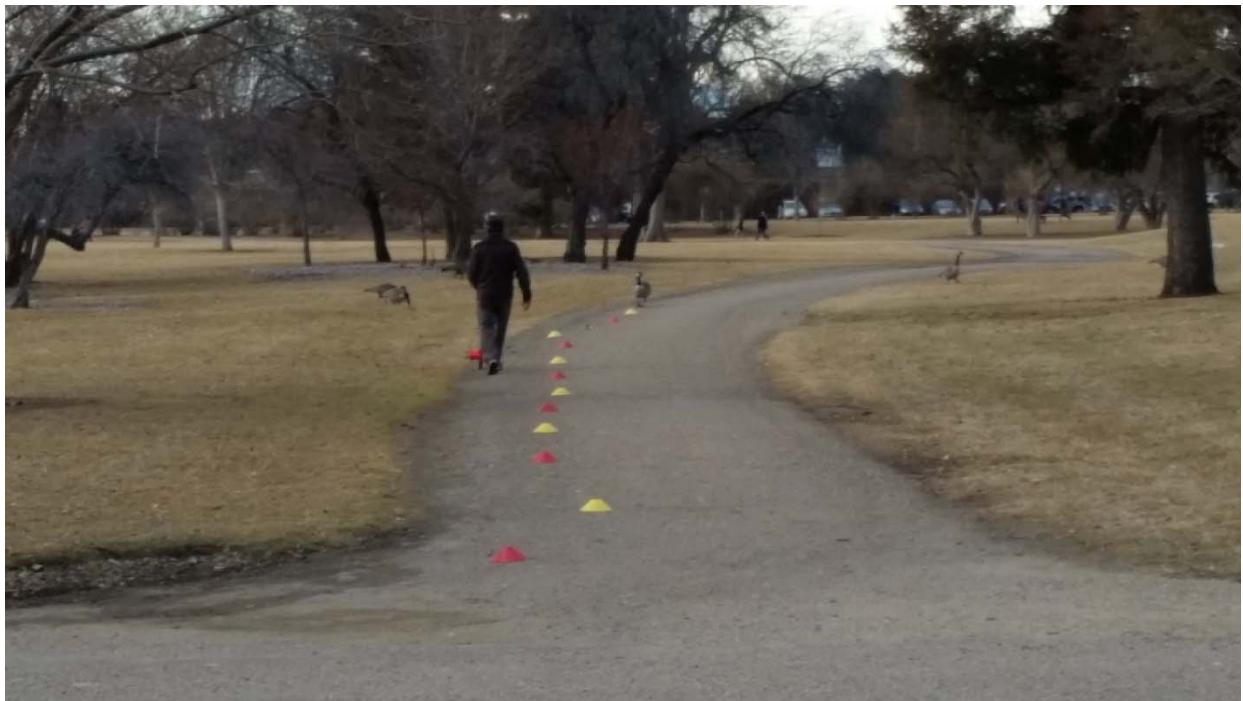
Southern Extent of Area 10

The Mile High Loop borders a hardened surface in three areas. Along York Street, the Mile High Loop borders a sidewalk. In this area, the Mile High Loop reduces to a width of 36". Along Colorado Boulevard, the Mile High Loop borders a sidewalk with a width of 30". In this section, where the Mile High Loop intersects the lawn in front of the Denver Museum of Nature and Science (i.e., "the Mountain View"), the loop trail is anywhere between 10" wide and non-existent.

This is a long stretch of trail needing repair. It is 650 feet long. Additional impacts to this section occur from rill erosion associated with the H2O Odyssey fountain pumps and a storm sewer outfall near this area's southern extent.

- Direct water from the storm sewer outfall either away from the trail or level the water into laminar sheet flow prior to intersection the trail
- Fill needed = 4,134 cubic feet ($650 \times 67 \times 1.2 \times 8$)
- cubic feet fill needed is defined as the length of trail to repair in feet X 0.67
 - o $0.67 = 8"$ depth for new trail construction
 - o (x8) Trail is variable in width and a mean width of 8 feet is used calculations
- 20% compaction (1.2) is factored in for new trail construction

*Preferred option – Complete removal of the hardened trail for the entire 650 foot length of this section and re-installing a crusher fine trail in this area. This area of hardened surface is no longer necessary for maintenance, since the concrete walkway adjacent to the H2O Odyssey fountain now serves as a better route for maintenance vehicles.
