City Park Mile High Loop 2015 Trail Condition and Assessment

The following assessment is provided to Denver Parks and Recreation by the City Park Alliance to assist with recommendations for maintenance and rehabilitation of the Mile High Loop trail in City Park. All decisions on maintenance, and capital construction in City Park are to be directed through the City of Denver's Parks and Recreation department.

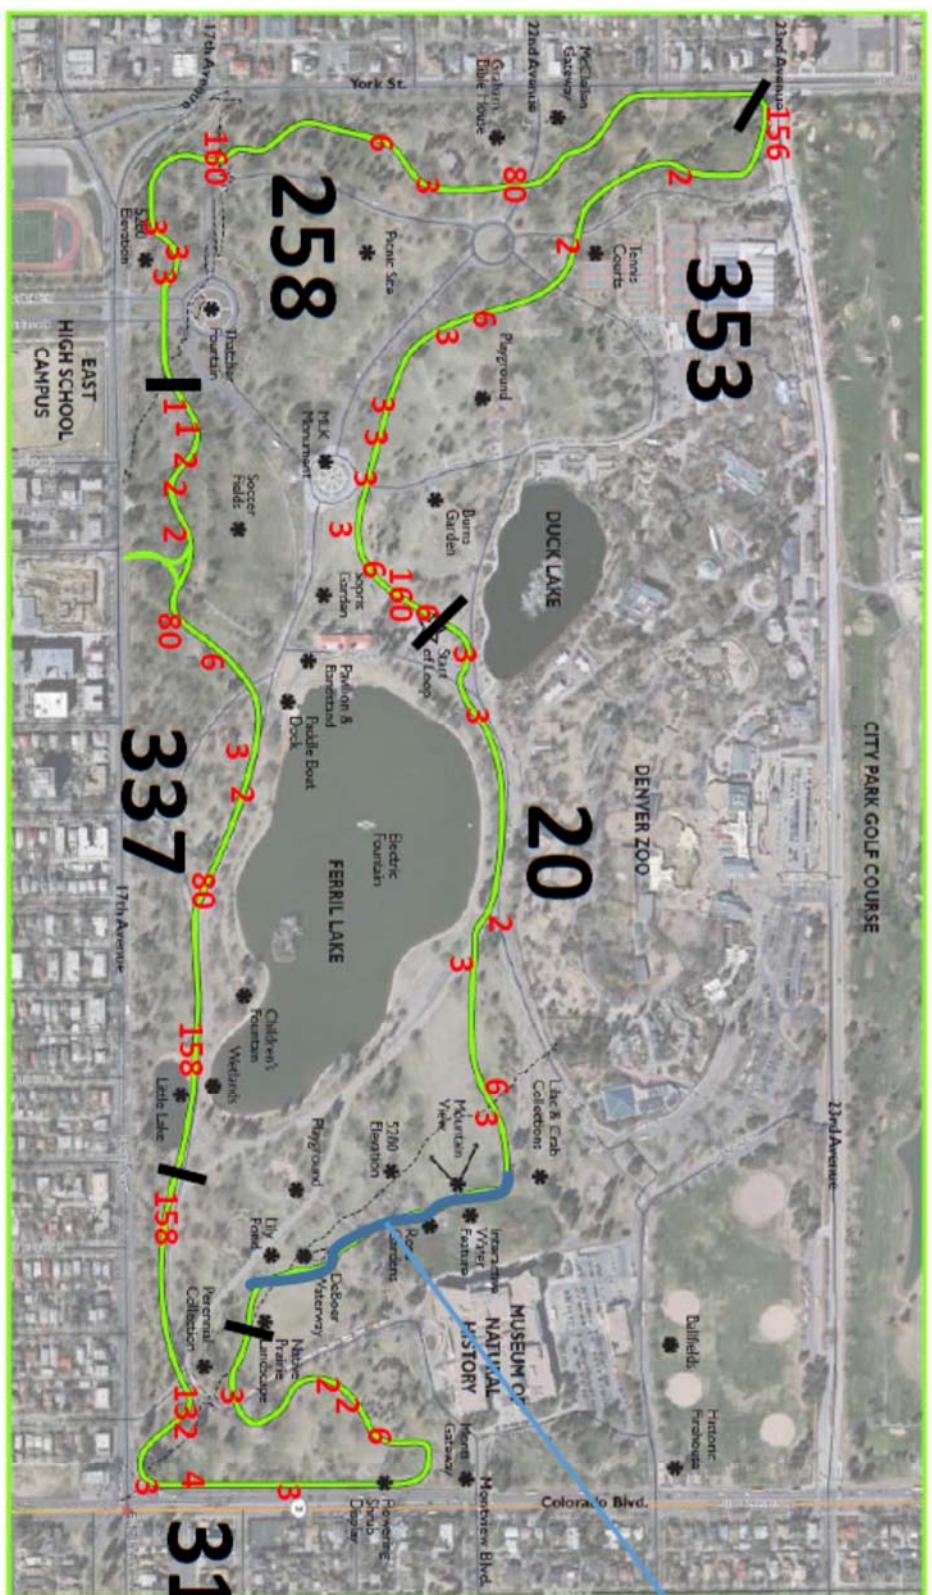
Problem Area 10 Additional Costs:

4,134 cf
for full
replacement
not
included in
per/km total

- ~\$330 – Cut asphalt - \$.51 per linear foot minimum charge
- ~\$6,500 - Remove asphalt 6,500 sf estimate
- ~\$5,425 - 155 cubic yards crusher fines
- ~\$6,500 – Install/site prep costs
- ~\$1,000 – Site re-vegetation
